SERVICE NO. 1258

BULLETIN

Date: June 5, 2013

FUEL VENT VALVE INSPECTION

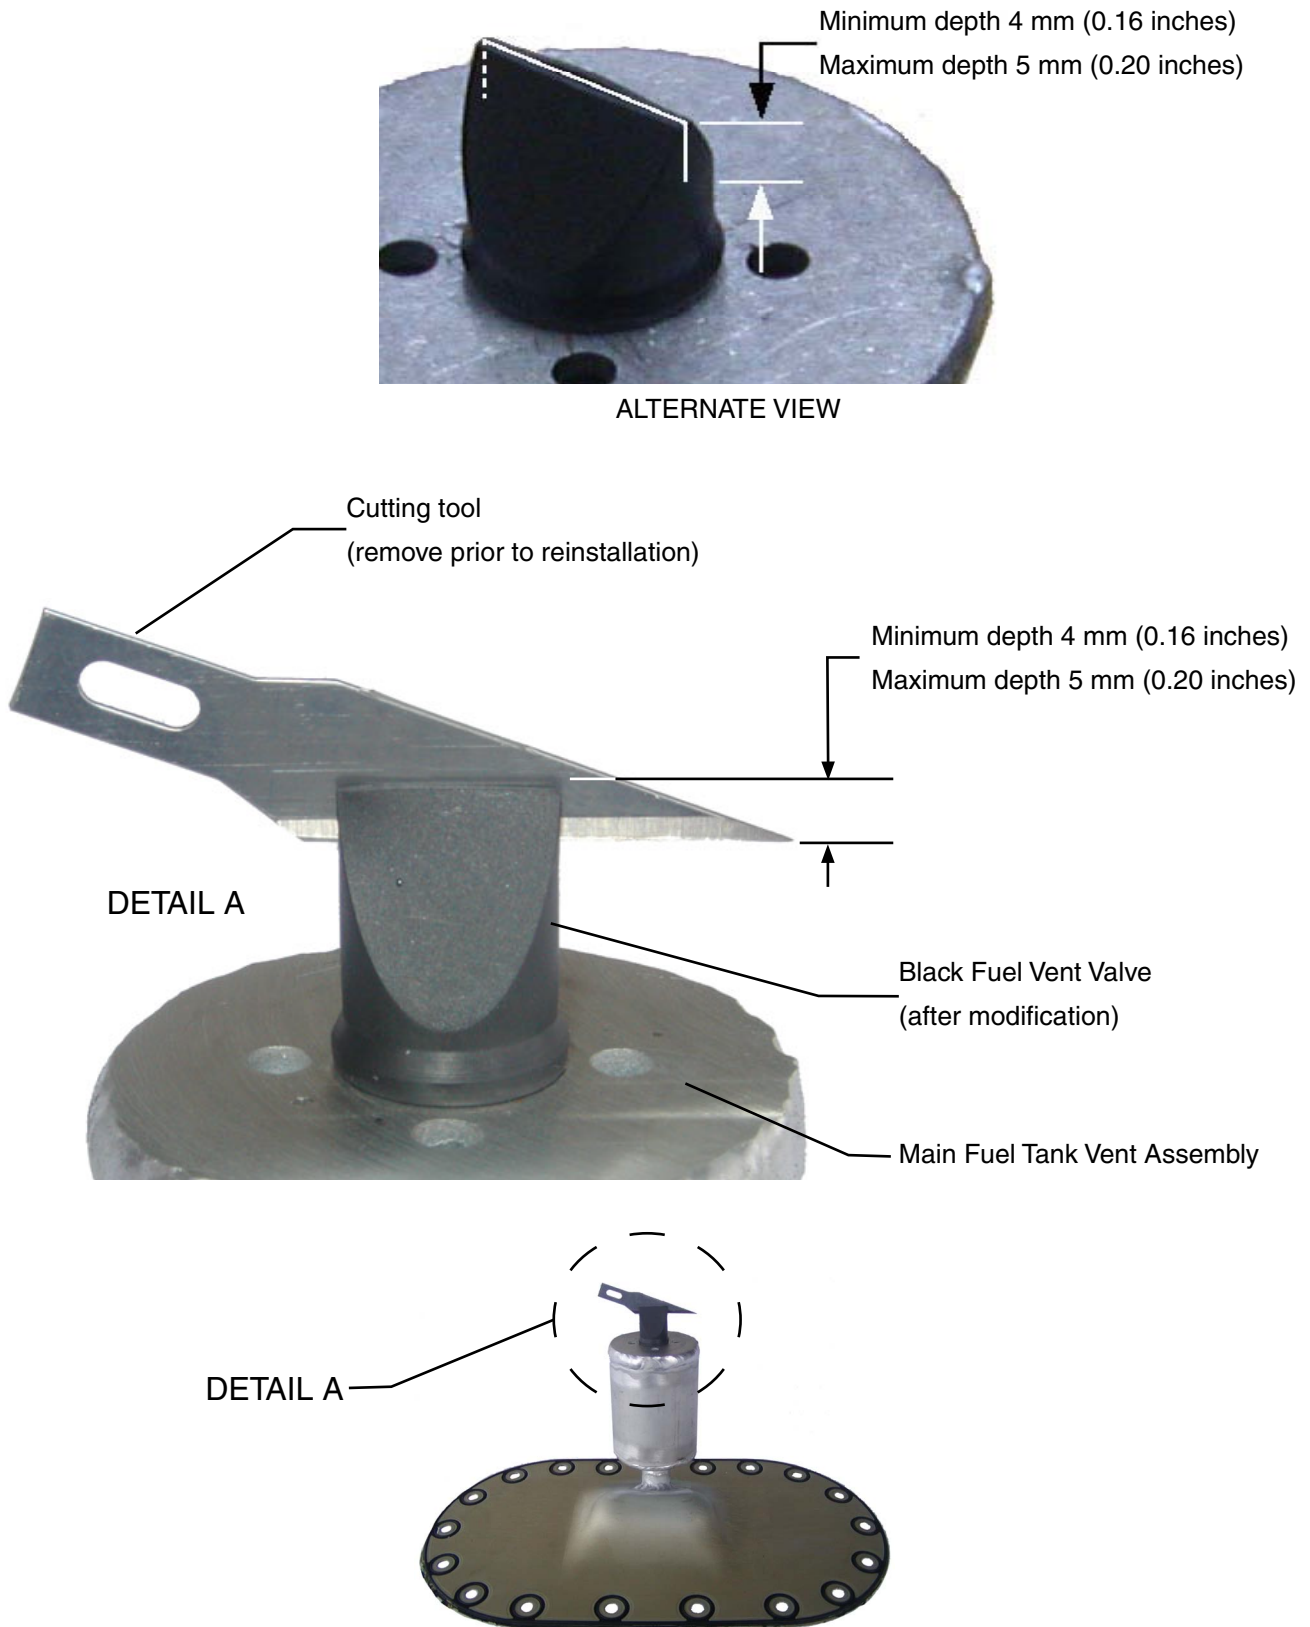
Figure 1

Main fuel tank vent assembly, as removed from aircraft wing.

NOTE: Cutting tool shown for illustration purposes only, to clarify depth of cut. Remove cutting tool prior to reinstalling the main fuel tank vent assembly.

1. Remove the main fuel tank vent assembly, retaining all screws for later reinstallation.
2. Using a razor blade, scalpel or other suitable sharp tool, carefully slice the duck bill portion of the black fuel vent valve, as shown in Figure 1.

NOTE: When properly completed, the existing (prior) opening at the end of the duckbill will reside on the same plane of symmetry as the enlarged (newly cut) opening.
